HISTORIC STRUCTURE ASSESSMENT REPORT

SNEE FARM (MAIN HOUSE)

CHARLES PINKNEY NATIONAL HISTORIC SITE
Mount Pleasant, South Carolina

1997

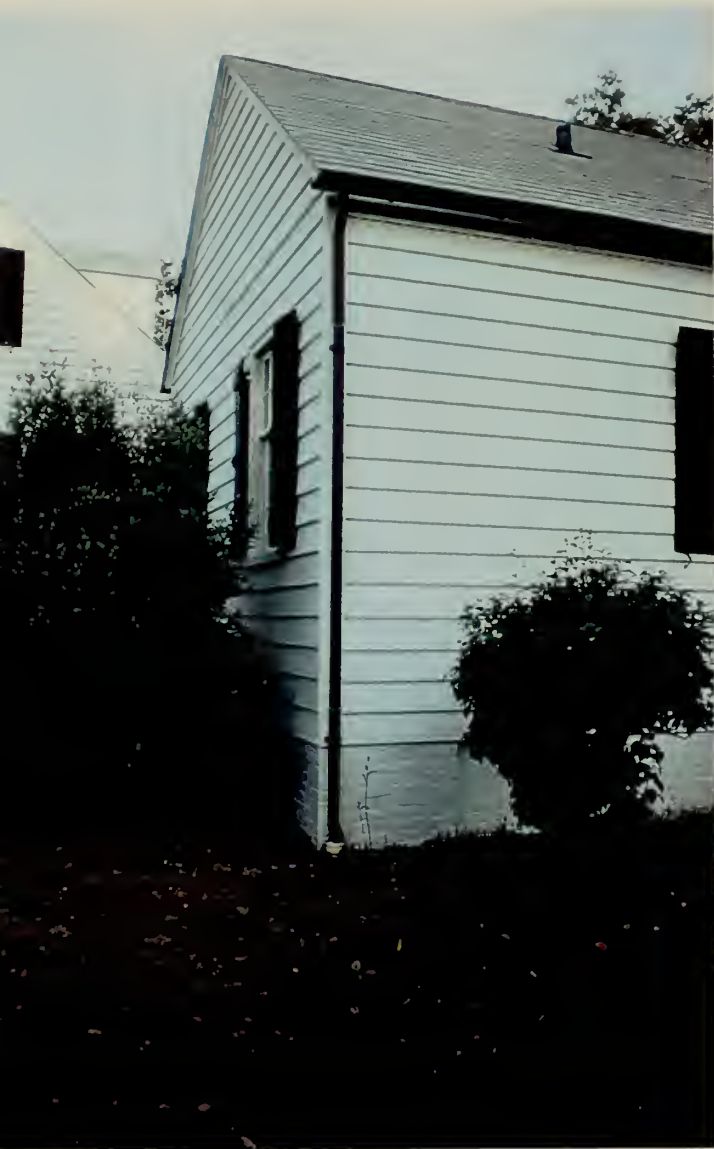
Photo shows the southeast corner of the east wing; note the downspout drains right in the ground adjacent to the brick wall foundation and causes damage.

1. Downspouts drain directly at the foundation of the structure and this causes problem for the settlement of the brick piers and basement flooding.

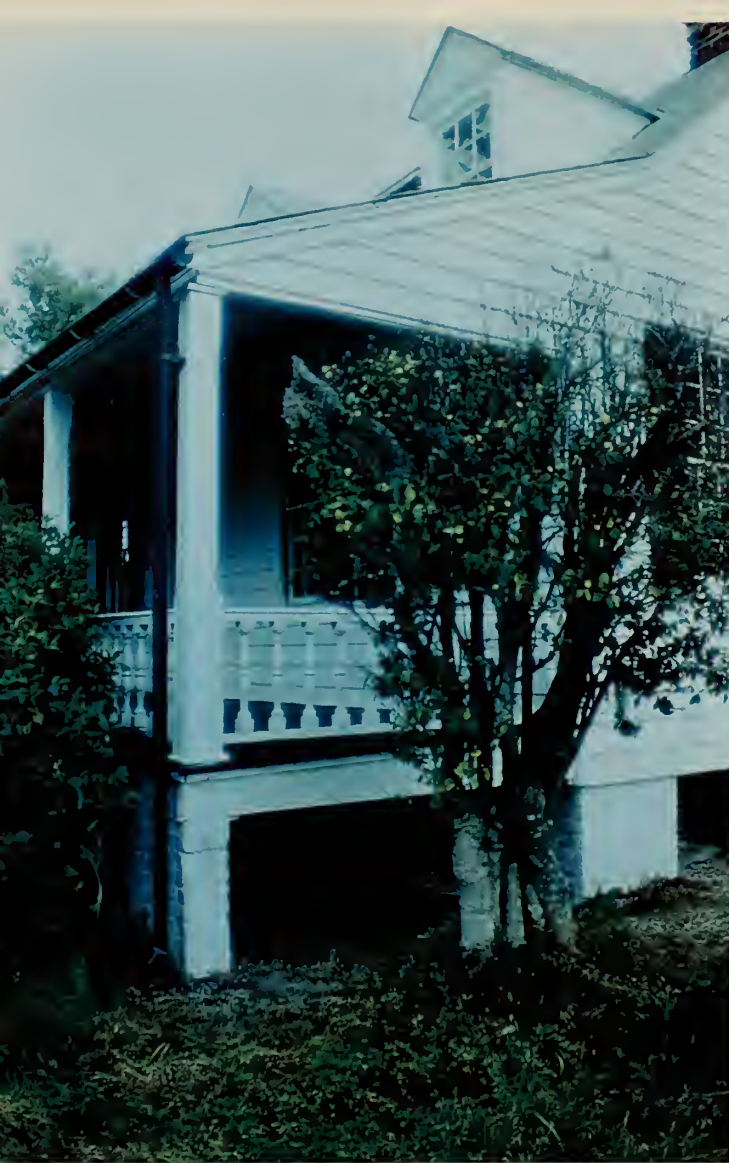
Southeast elevation of the porch. Note the size of the copper gutter and downspout. It appears the size of downspouts are not enough to drain all of the water from the roof. Downspout drains adjacent to the brick pier and causes damage.

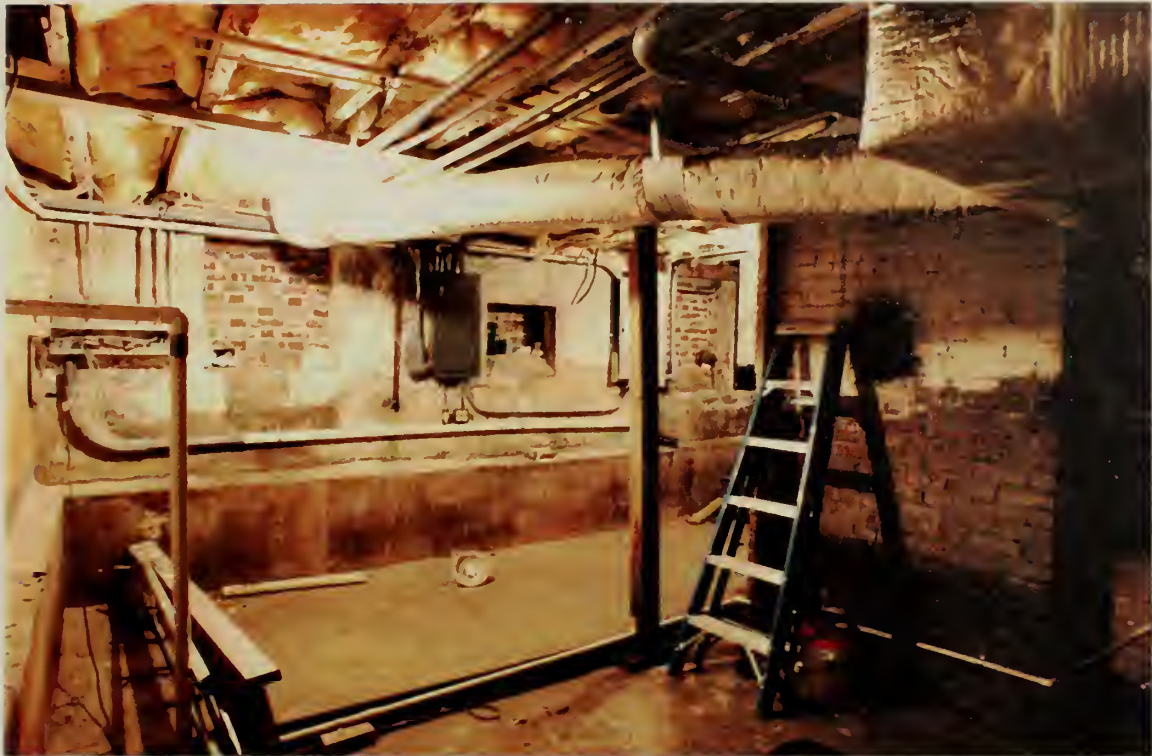
View toward the west of the basement under the west wing. Note basement windows are covered with bricks and the girder supported with a temporary 4"x4" wood post and a jack. Basement openings should be opened to promote air circulation, reduce moisture, and bring some light into the basement.

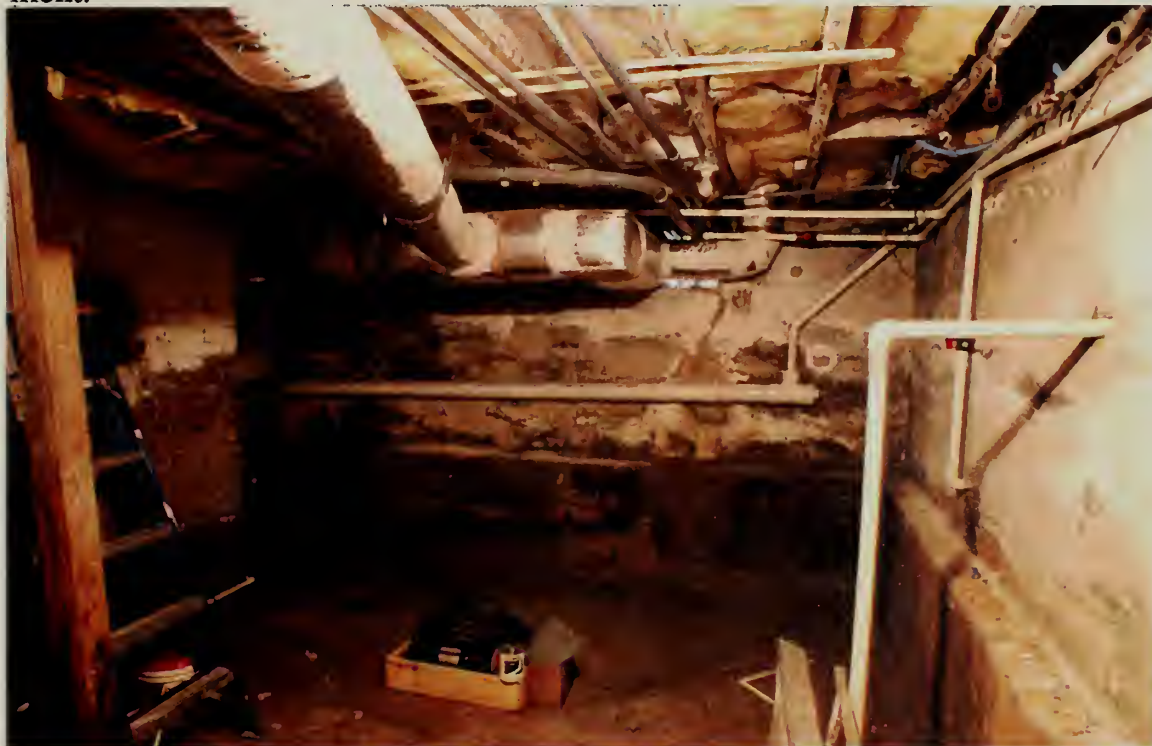
View toward the east wall of the basement under the west wing. Note the surface damage on the concrete wall caused by moisture.

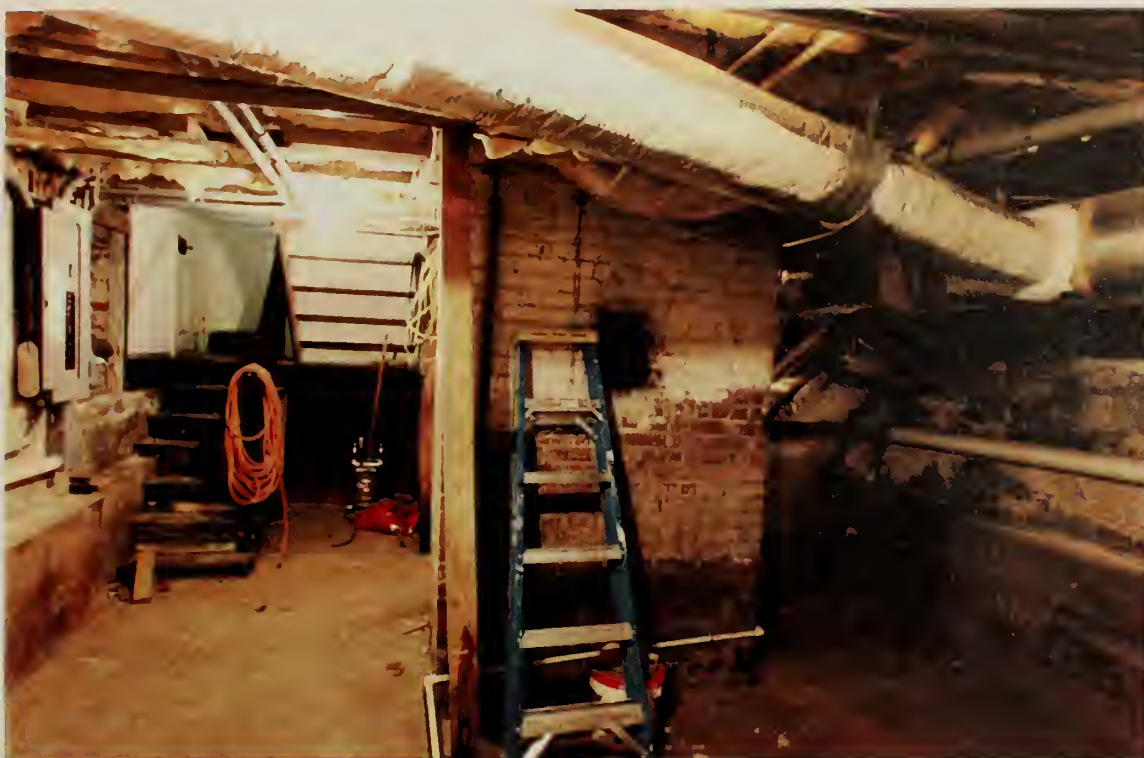
View of the basement toward the north. Note the basement stair on the left of the picture and the unaligned post under the girder adjacent to the brick chimney and ladder.

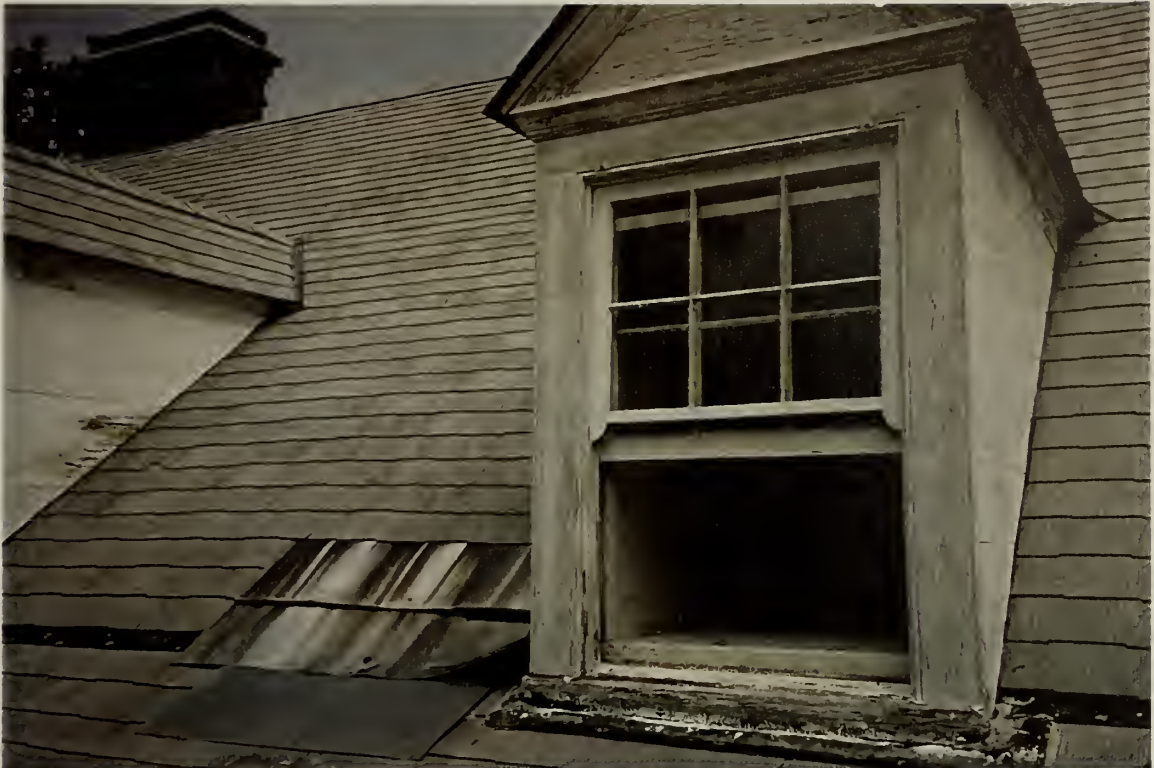
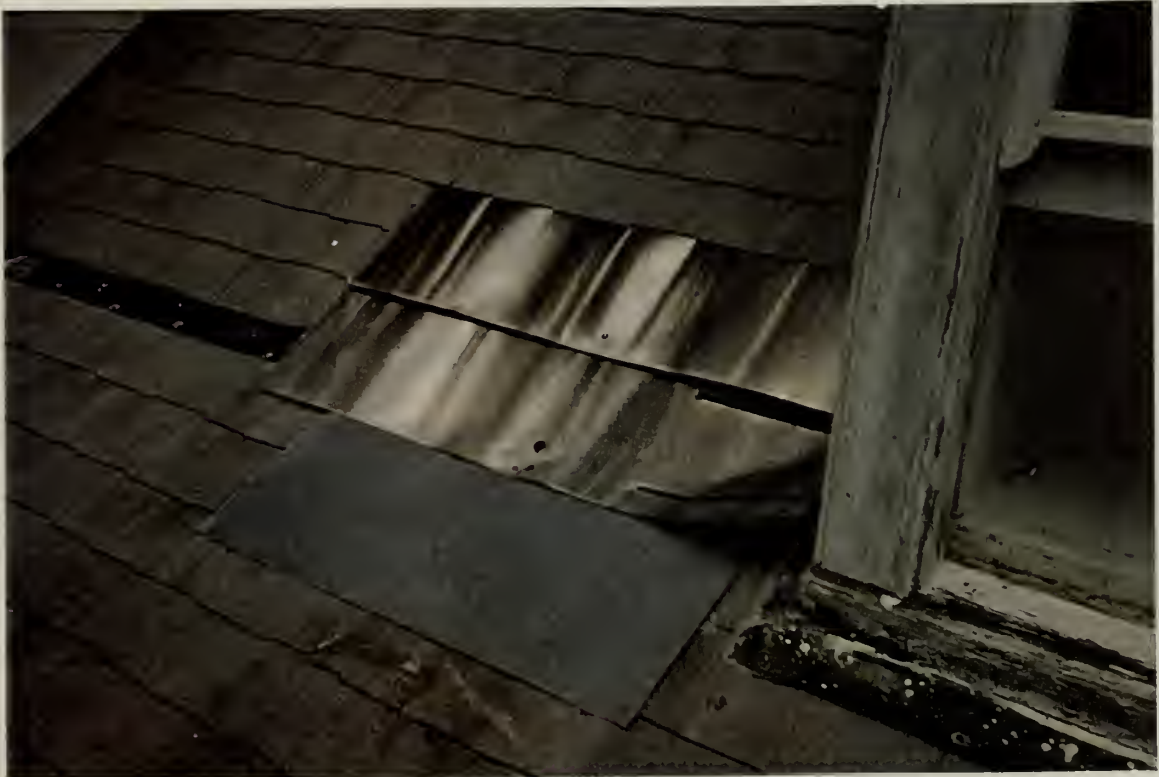
These photos show the damage and broken fiber cement shingles on the left side of the middle dormer in the south that has been covered with sheet metal. Sheet metal has not been installed properly and that has caused rainwater to penetrate the roof and eventually the ceiling of the first floor.

1. Damaged and broken fiber cement shingle on the left side of the middle dormer in the south part and the other parts of the roof.
2. Temporarily covered damaged area in the left part of the middle dormer in the south with sheet metal. Sheet metal cover has not been installed properly and that caused rainwater to penetrate to the roof and eventually to the ceiling of the first floor.

1. Replace all of the damaged fiber cement shingles with new, match the size, shape and color with the existing. For the removal of the damaged shingles and installation of the new shingles follow the Supradur application instruction.
2. Remove all of the temporary sheet metal from the area adjacent to the middle dormer in the south.
3. Repair the damaged sheathing in proper way.

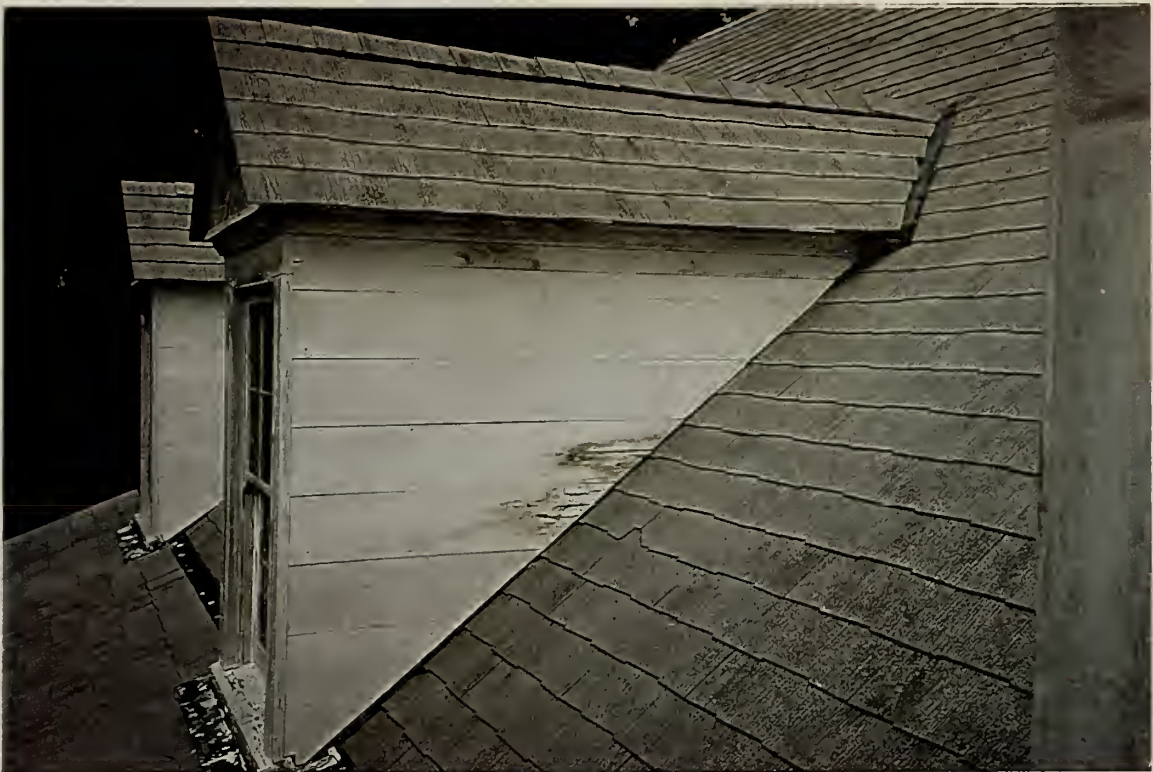
Damaged wood siding on the dormer walls in the south part of the main building.

damaged wood board siding on the dormer walls in the south part of the main building.

Replace all damaged wood siding board in the dormers in the south part of the main building with new, match the size, shape and the quality of the boards with the existing.

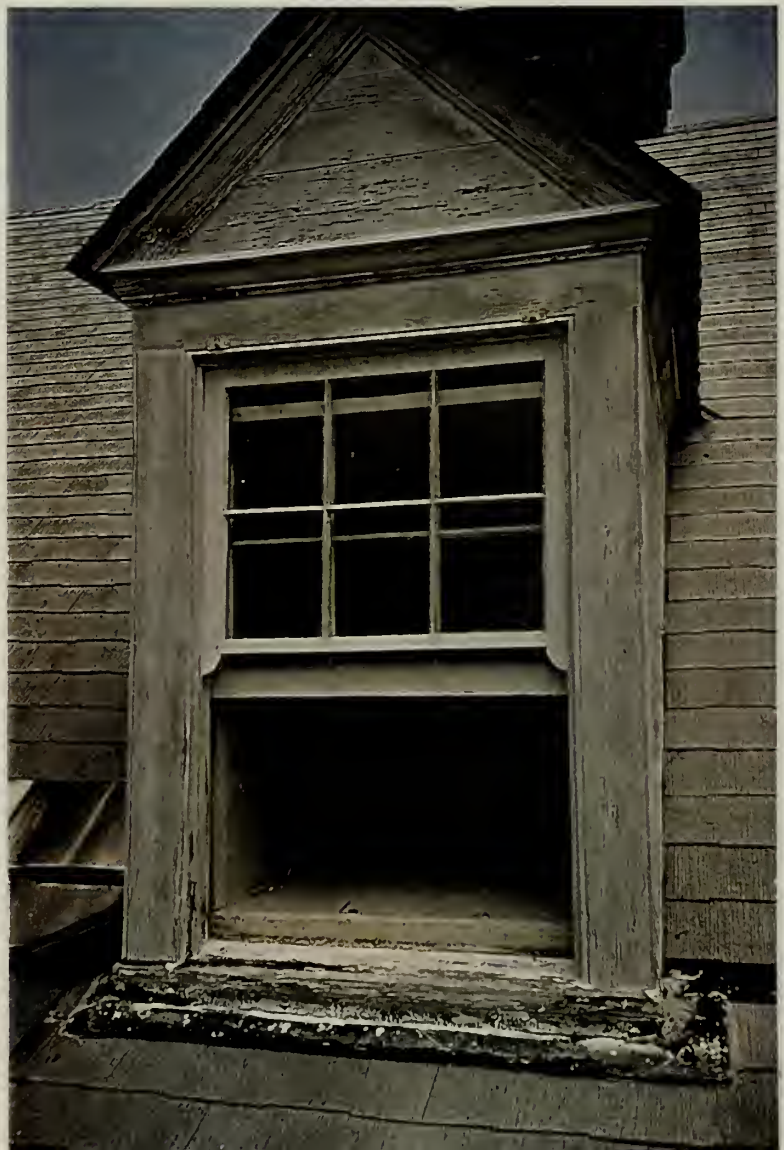
Some of the existing copper flashing on the dormer sills are not installed in a proper way. This has caused the rainwater to penetrate under the metal flashing through the roof and finally through the ceiling above the north entrance door. See detail C in the appendix.

Some of the existing copper flashing on the dormer sills in the north part of the main building are not installed in a proper way. This has caused the rainwater to penetrate under the metal flashing through the roof and finally through the ceiling above the north entrance door.

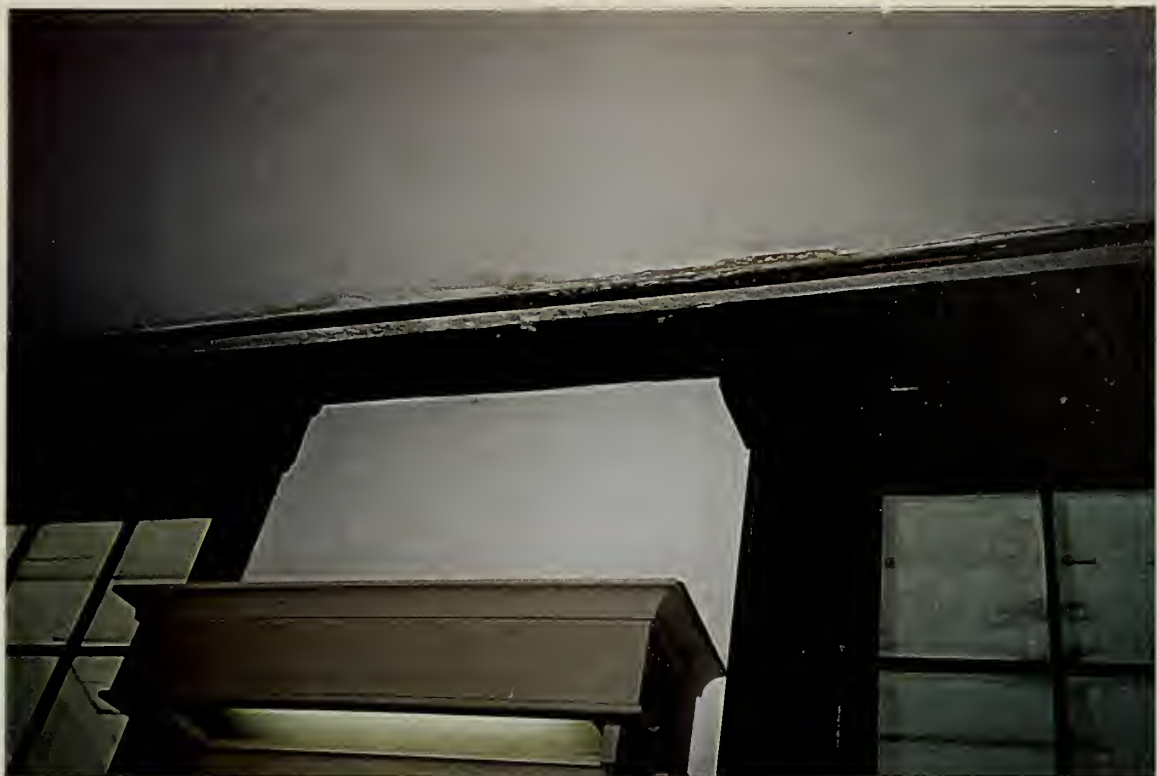
Photo shows damage (in the corner where the wall meets the ceiling) caused by penetration of rainwater from the corner of the middle dormer in the south into the roof and eventually to the ceiling.

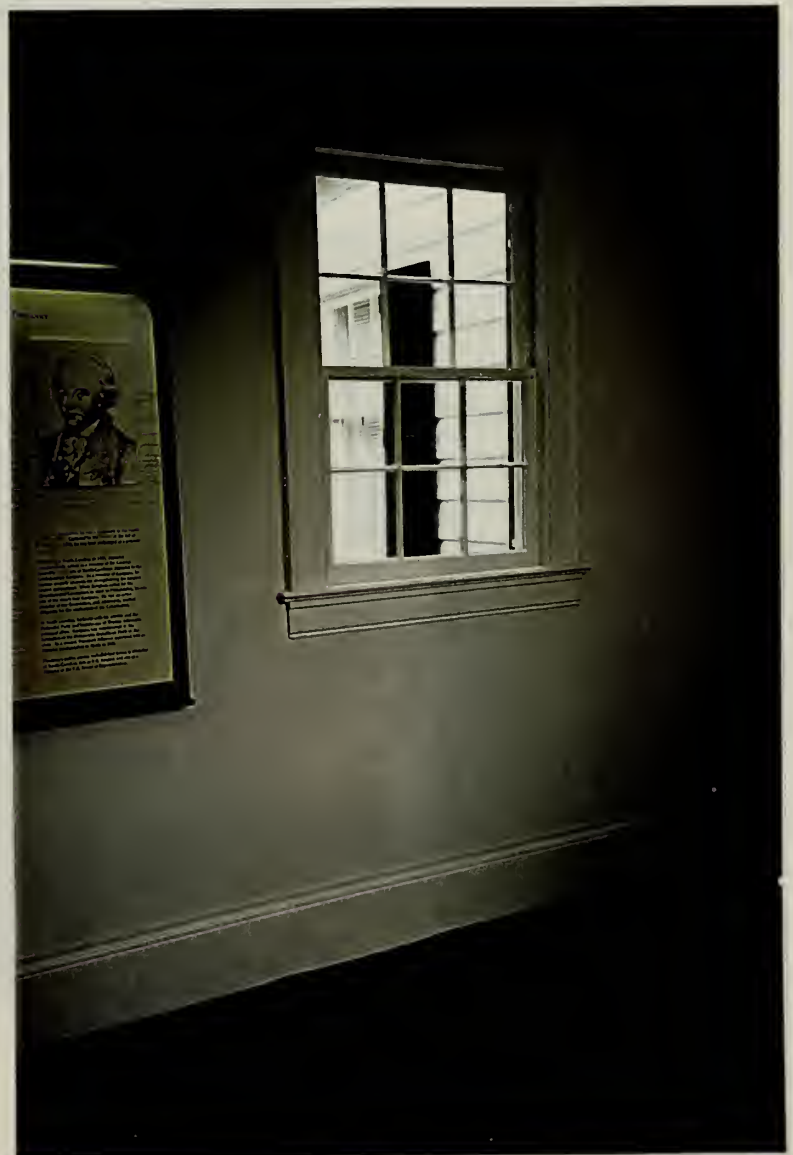
Photo shows the damaged wall in the classroom lobby under the window. This was caused by the penetration of rainwater from gutter overflow on the window sill and eventually in the wall.

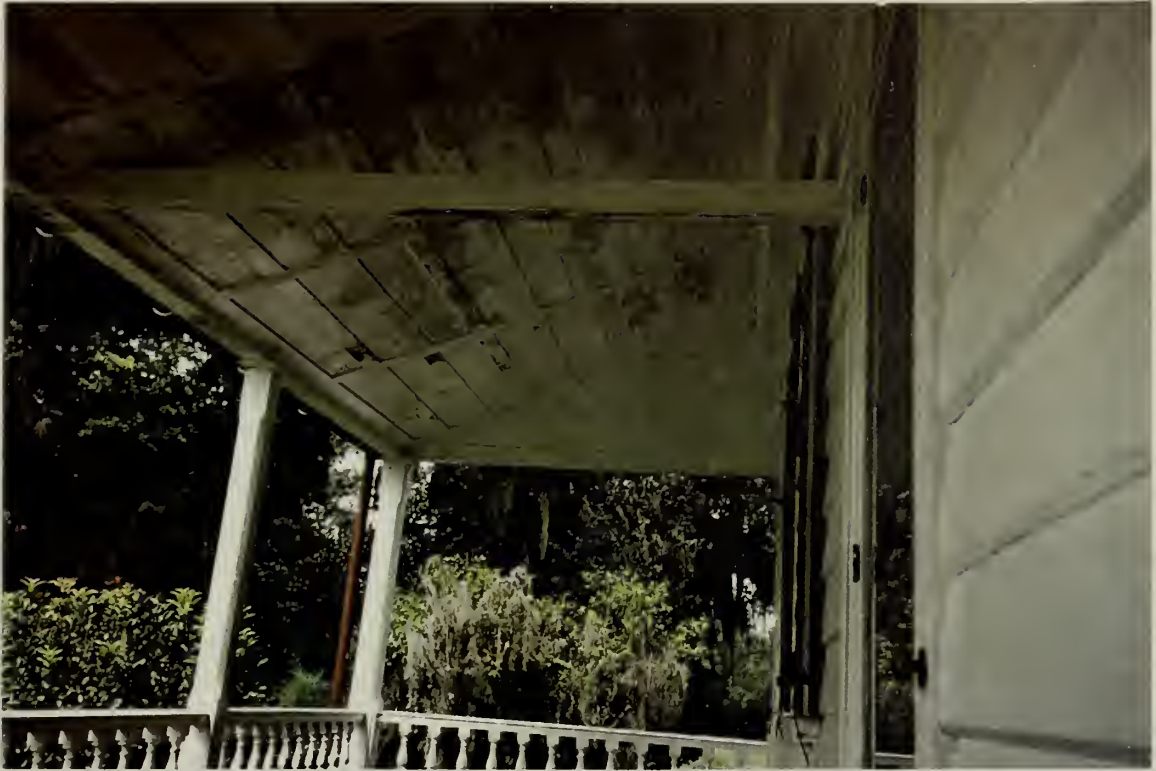
Mildew damage on the paint surface of the south porch ceiling , similar to this is on the surface of the gable in the east and west part of the main building.

2. Mildew damage on the paint surface around the gable area in the east and west part of the main building and on the south porch ceiling.

4. Paint all of the dormers and damaged mildew area. The painting job should take place in a dry season when the moisture in the environment is low, perhaps in the fall

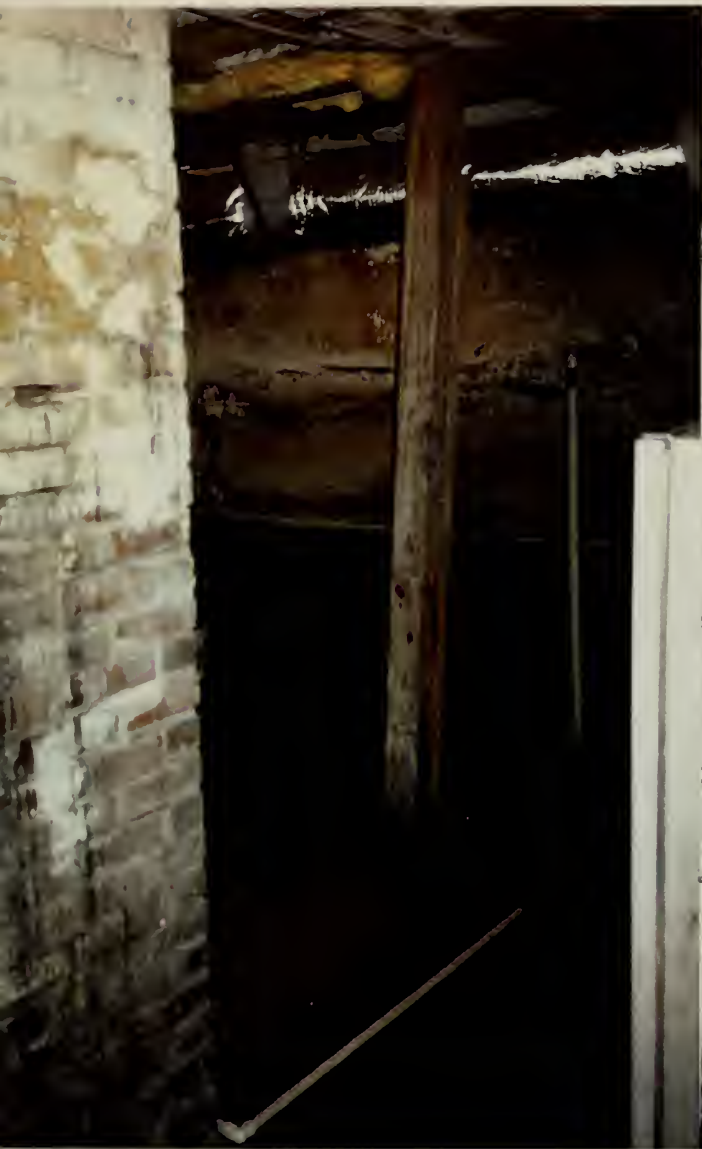
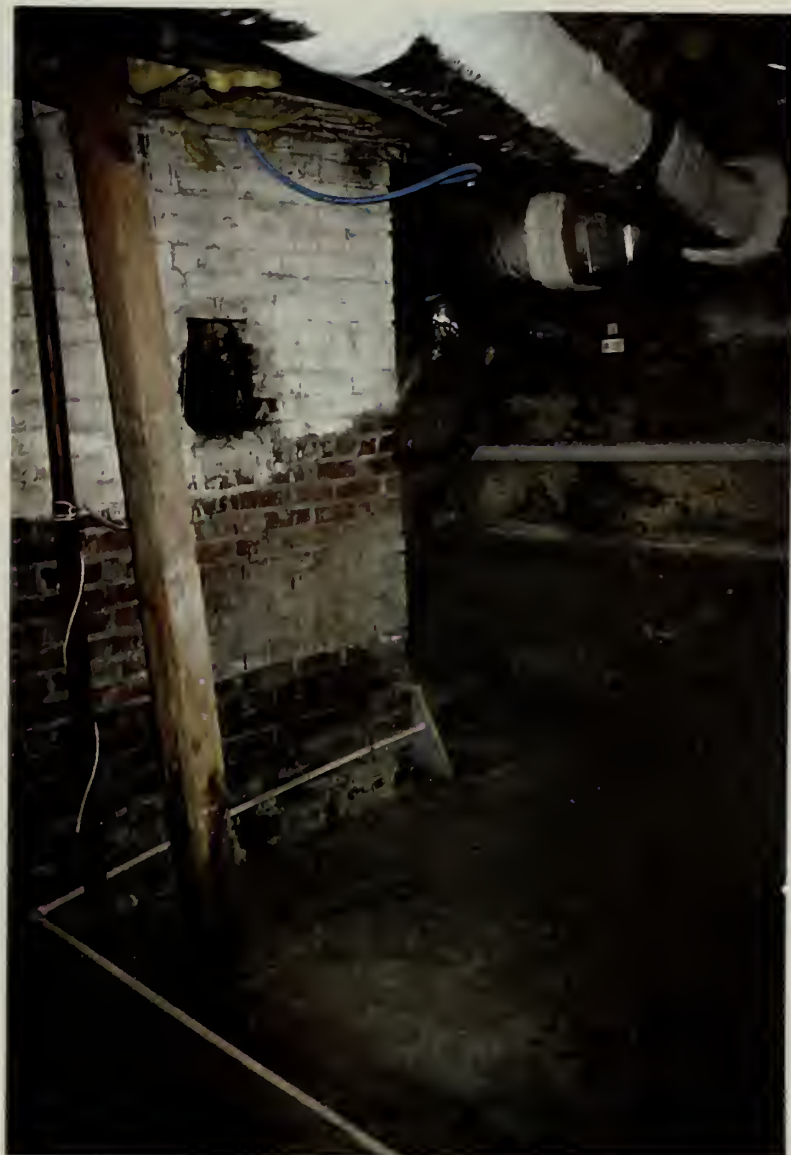
Photos show basement joists in the south part temporarily supported with an un-aligned post and a metal jack close to the brick chimney

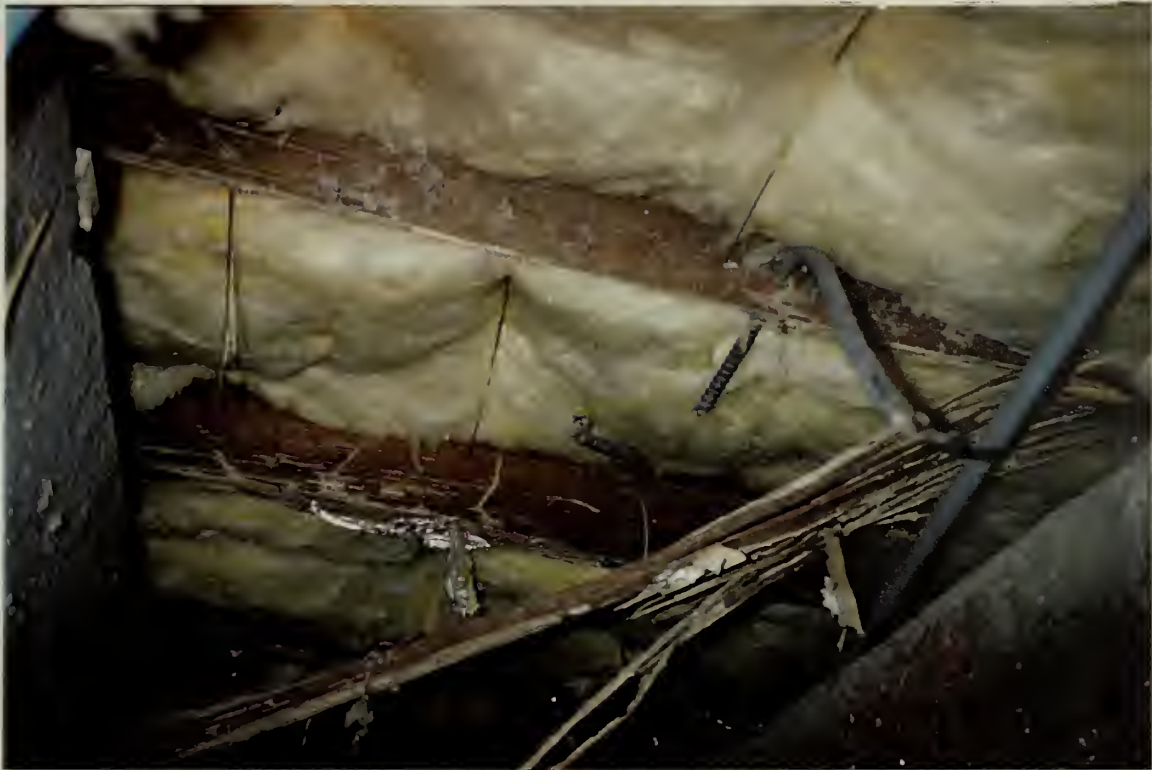
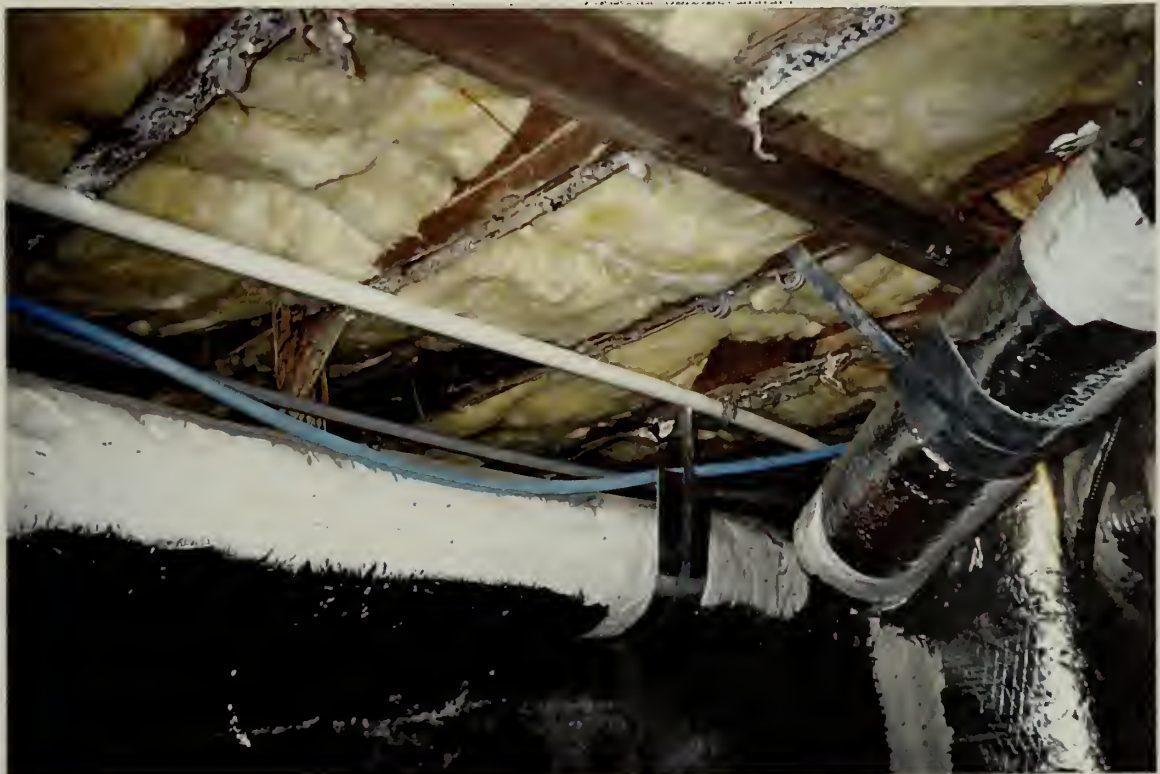
These photos show the termite damage in the joists and girders in the basement ceiling in the west wing in the north part of the brick chimney. These damaged joists and girders need to be replaced with new.

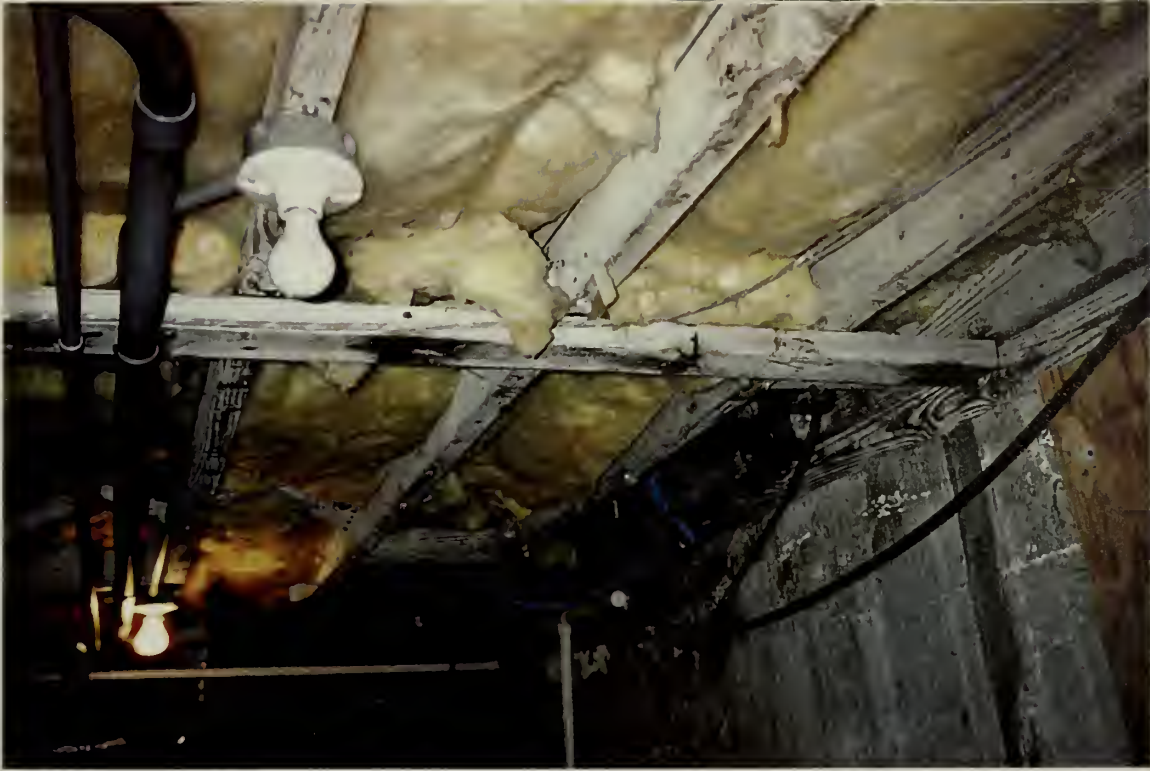
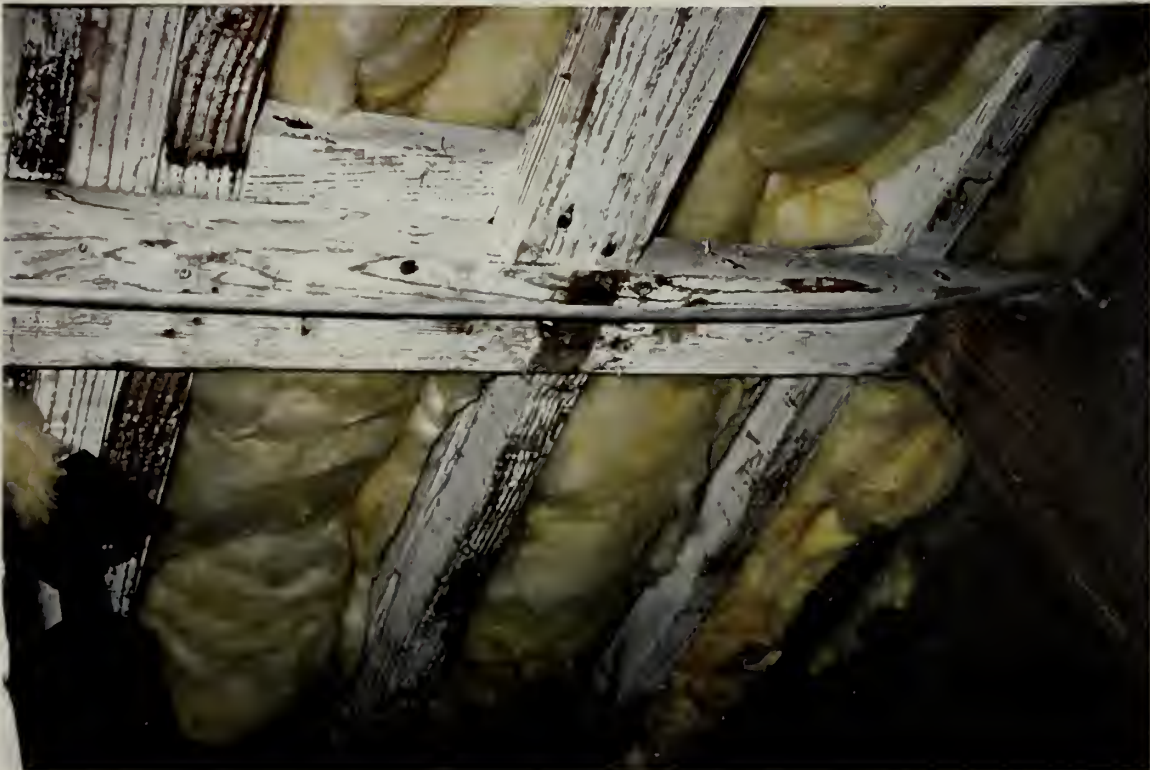
These photos show the ghost silhouettes of the wood supports on the 2"x4" wood girder every 24" on center. At the present time this girder is supported by a wood post (3-2"x4" wood) and a metal jack in the area close to the chimney.
